*Early Domestic Architecture  
of Connecticut*

*By J. Frederick Kelly*

J. Frederick Kelly, A.I.A.

New Haven: Yale University Press

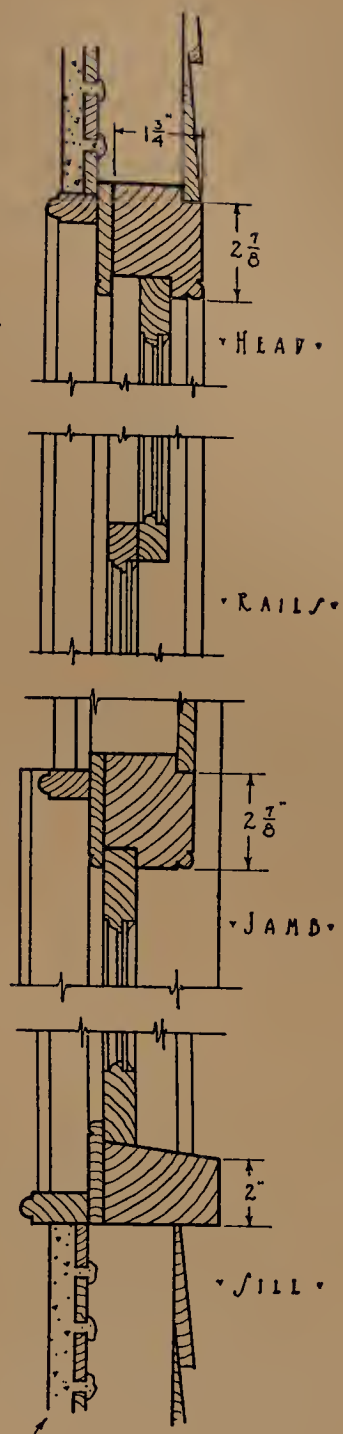
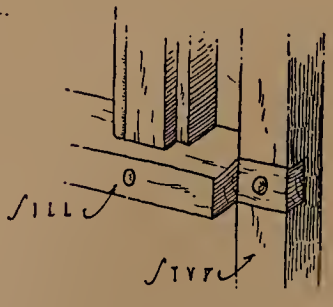
FIGURE 95.

for these two points soon became fixed. A pane of glass six inches wide and eight inches high was the unit which determined both the size of the sash and the proportion of the window frame. The earlier forms of double-hung sash, almost without exception, are composed of these 6-by-8-inch lights, which were evidently a standard size. Sash which were four lights wide were quite invariably the rule, though in height they varied, being two, three, and four lights high. The earliest type of double-hung window with rectangular panes is that whose lower sash is two lights high and the upper three, or *vice versa*. A later and more common arrangement consists of a window containing two sash of equal height, each containing twelve 6-by-8-inch lights, as in Figure 95. With the adoption of the 6-by-8-inch light as a standard, there came another

In windows of the double-hung type, the upper sash was fixed, being rabbeted into the frame. The lower sash only was operated; it slid up and down and was held at various heights by a spring catch on the jamb. The counterbalanced sash of modern type, with its pockets in the jambs for weights, was as yet unthought of. The frames of these early windows were of solid oak construction, similar to those of the casement variety. The jambs were framed into the head and sill by means of the customary tusk-tenon-and-mortise joint, and secured in place by wooden pins. Like its predecessor of the casement type, the window frame was secured in place by mortising the projecting ends of the head and sill into the studs on either side. The construction of a typical window of this type is shown in Figure 95.

Since walls were generally constructed of 3-by-4-inch studs set flatwise, with less than one inch of lath and plaster on the inside and clapboards nailed directly to them on the exterior, the total thickness of outside walls was in the neighborhood of five inches. If the house were of "plank-frame" construction, this was still less. Window trim was at first set flush with the plaster on the inside, so that the two sash, each an inch thick, brought the outside of the window frame, with its enclosing rabbet, out beyond the face of the exterior wall covering. This is a marked characteristic of these early window frames. Another feature common to them is the projection of the head and sill beyond each side of the jambs, as shown in Figures 95 and 96.

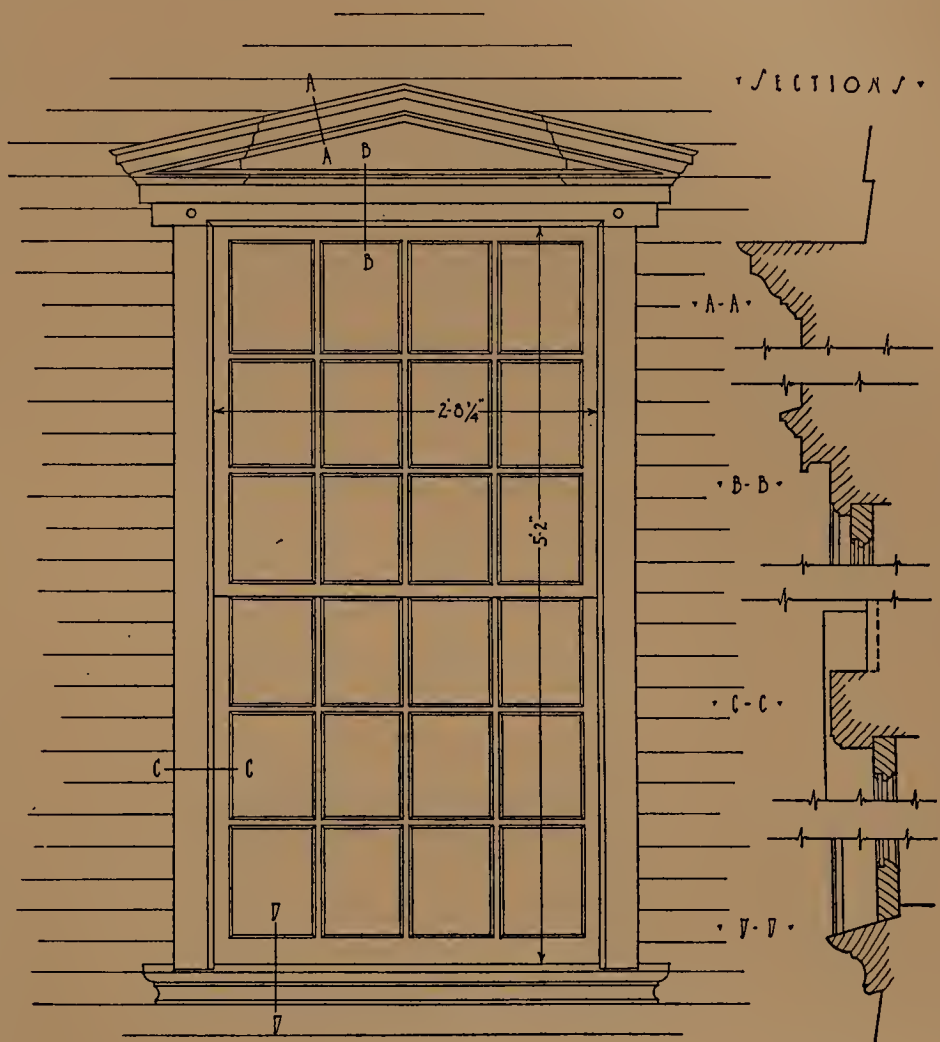
FIGURE 97.

One of the first attempts to elaborate the double-hung window frame on the exterior was the addition of a cornice or pediment to its head. This form of ornamentation often accompanies the heavy projecting frame previously described. The windows on the front of the Belden house in Wethersfield (*circa* 1753) and of the Trumbull house in North Haven (1761) are examples of such treatment. (Figure 97.) From the drawing of the Belden house windows it will be seen that there is a slight break of offset in the rake mouldings, just above their intersection with the horizontal members. This is a characteristic feature of these pedimented window heads, which are common to the period 1740-1750. They appear to belong chiefly to houses of the central-chimney type. Very often this form of elaboration is to be found only on the front of the house, the windows on the ends and rear being quite plain.

· WINDOW ·  
/ BELDEN HOUSE - WETHERSFIELD /

Curiously, the sills, which in earlier work had been handsomely moulded, as in Figure 97, generally became quite plain after the adoption of the outside casing, or architrave.

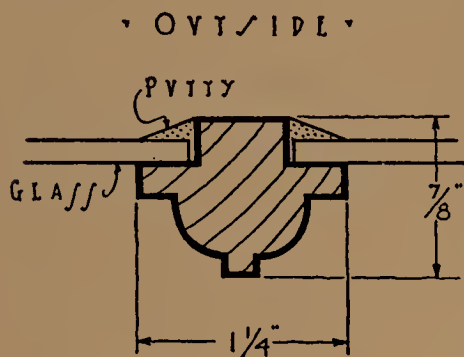
FIGURE 99.

Sash bars, or muntins, in early work measure as much as  $1\frac{1}{4}$  inches in width (Figure 99), the average up to about the last quarter of the eighteenth century being about one inch. About that time a decided narrowing took place, until, in work executed after 1800, the muntin is extremely thin and characterless. This change was largely due, no doubt, to the increased thickness of the sash material; the muntin became correspondingly thin and deep in section, rather than broad and shallow. The same muntin section was used repeatedly in early sash, and there was practically no variation from the one type. (Figure 99.)

When glazed, the cupboard door was invariably made up of small panes of the conventional 6-by-8-inch size, set in broad muntins. These muntins, which were always moulded, were rarely less than an inch in width; some examples measure as much as an inch and a quarter. Since the doors were made of inch stock, the result was a broad flattened muntin, and the glass was necessarily set nearly flush with the inner surface of the door. (Figure 99.)

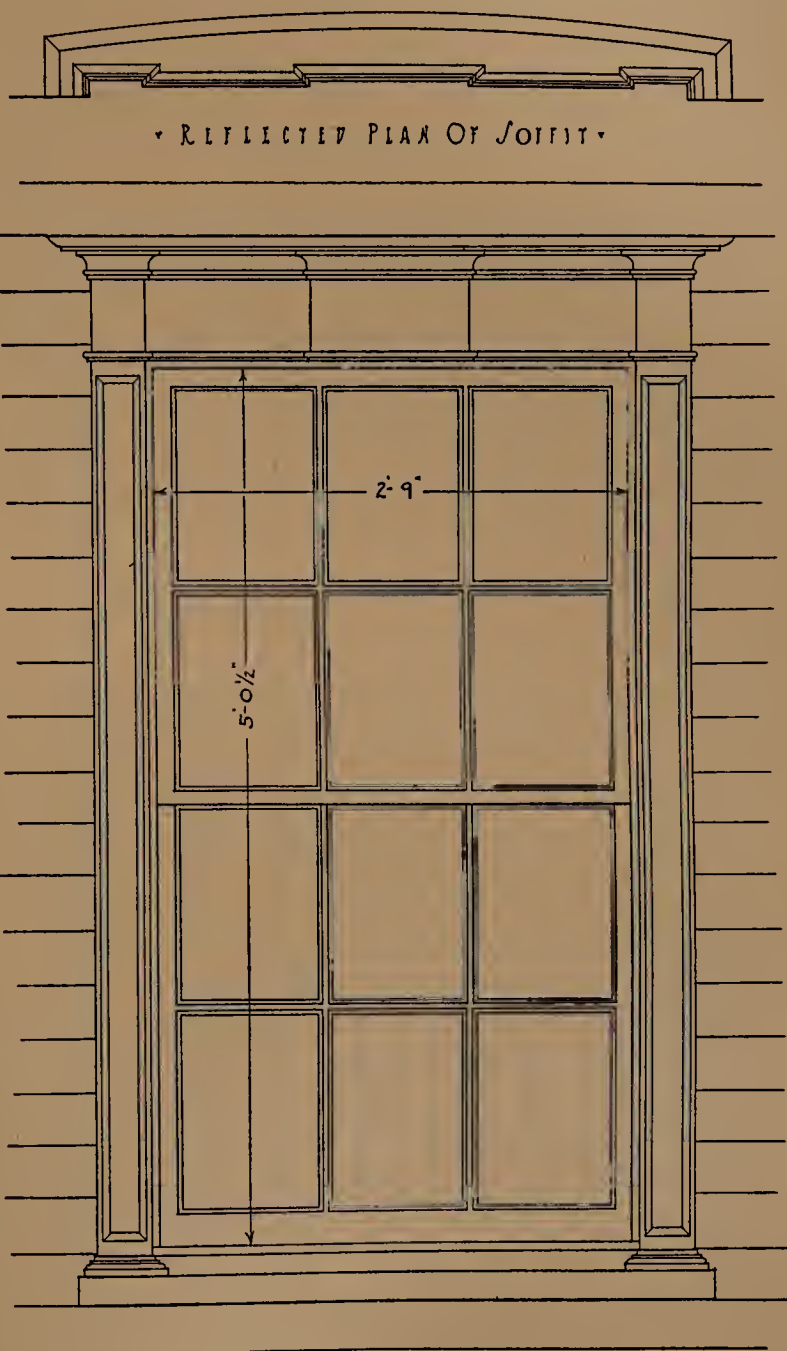
FIGURE 100.

• W I N D O W •  
 / NEW HAVEN /

Not until the muntin section became narrower and deeper did the custom abate of setting the glass very close to the outer surface of the sash. Eventually glass increased in size, and the dimensions of the individual pane became 8 by 12 inches. Six lights thereupon replaced the earlier arrangement of twelve. It should be noted that, although the panes became larger, the dimensions of the sash remained as formerly. (Figure 100.)

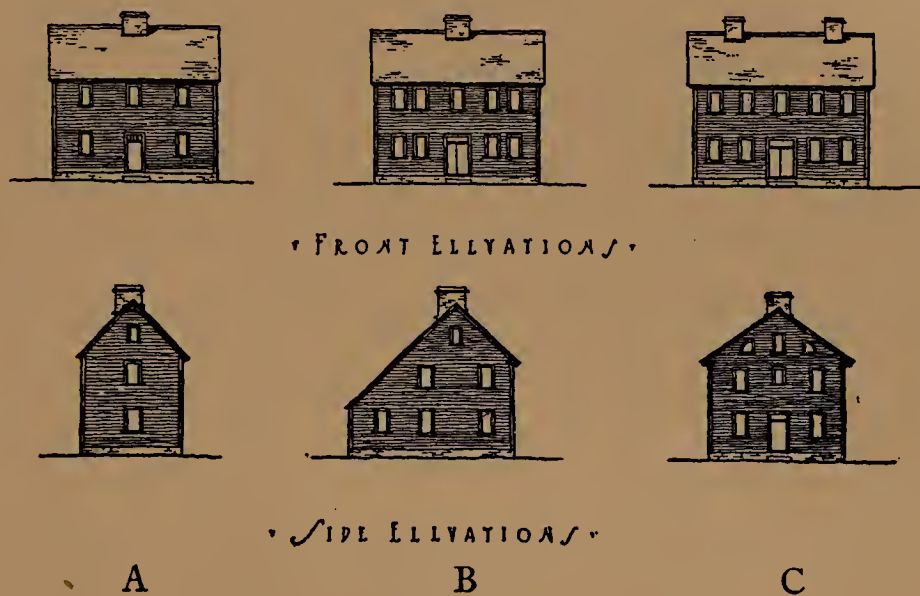
FIGURE 102.

Very often a valuable clue to the period to which a house belongs can be obtained through a study of its fenestration. This is especially true of the window arrangement or grouping of the front elevation. In Connecticut there appear to be three general methods of composition. (Figure 102.) First, there is that in which the façade has five window openings—one in the center of the wall of each front room, and one above the front entrance, as in A. This arrangement is typical of the central-chimney house of two-room plan. This was followed by the introduction of an additional window for each front room, making nine on

the front of the house, as in B. The distinguishing characteristic of this arrangement lies in the grouping of the windows of each front room very close together, really in pairs. This treatment belongs mainly to the house of lean-to type, or lean-to type of plan. Finally, in later houses of the central-hall type, the windows are no longer grouped in pairs, but spaced farther apart, the number, however, remaining the same, as shown in C. This rearrangement may have been due to some extent to the introduction of shutters, which would naturally have caused the windows to be spread apart, in order to permit the shutters to fold back against the house without interference.

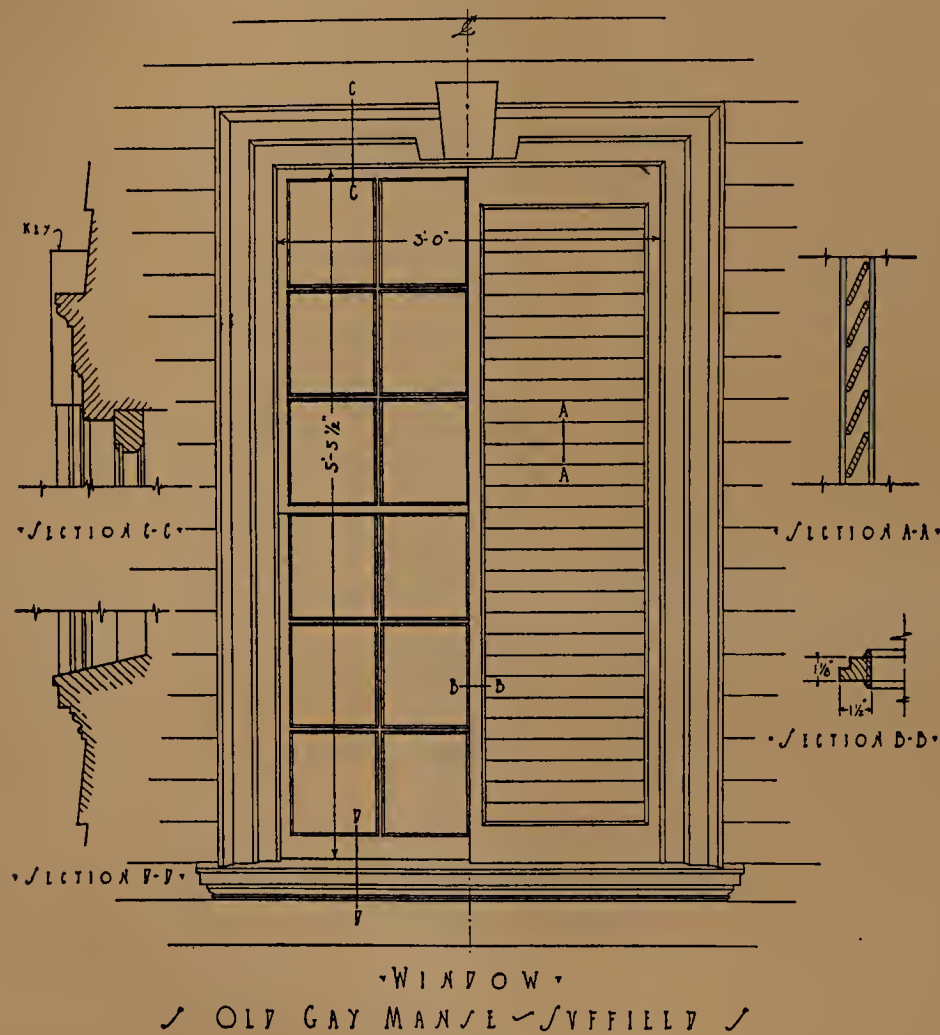
FIGURE 105.

as by their fixed slats. The average width of rail of the earliest specimens is not greater than  $1\frac{1}{2}$  inches, and the thickness varies from  $1\frac{1}{8}$  to  $1\frac{3}{8}$  inches. The ends of the slats were mortised into the stiles, which were finished with a small bead moulding. (Figure 105.)

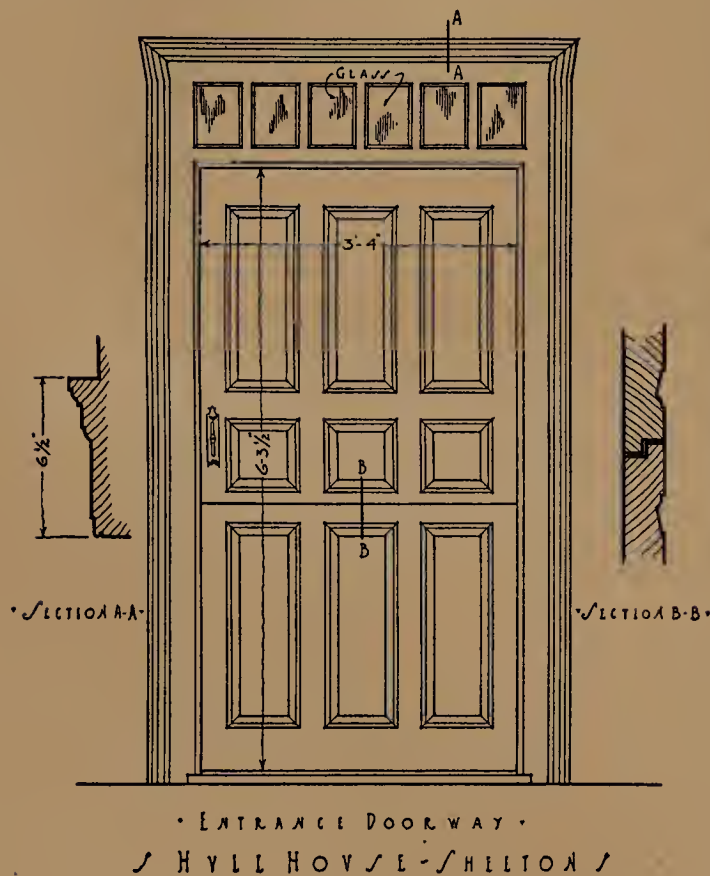
FIGURE 107.

the early builders attempted to bestow some degree of elaboration upon the front entrance before trying to do the same for any other part of the general fabric. Passing from the purely utilitarian type to the next stage of development, we find the rudely constructed door replaced by one of simply panelled form, at least one moulding applied to the casing, giving it the character of an architrave, and glass transom lights added, above the door itself, but enclosed by the door frame. (Figure 107.)

A glazed transom of this sort was perhaps more the result of actual need than of a deliberate attempt at elaboration, for through it came the only outside light which was admitted to the porch. Such transoms were usually made up of six or eight small panes, separated by broad muntins of plain form, which were rabbeted to receive the glass. The surface of the glass was always kept well forward and nearly on a plane with the muntins

The "Dutch" or, as it is sometimes called, "hatchet" door is probably of early appearance. (Figure 107.) Although its use persisted until a late date, it is not of common occurrence. The panelled door made its appearance about 1700. At first it was of simple form, with rectangular panels. These gradually increased in number and became of elaborate form. Panelled doors were commonly reinforced on the back, or inner side, with a three-fourths or one-inch sheathing, applied with horizontal joints. Even when this arrangement exists, the total thickness of the door is not more than two inches. The single door, at first

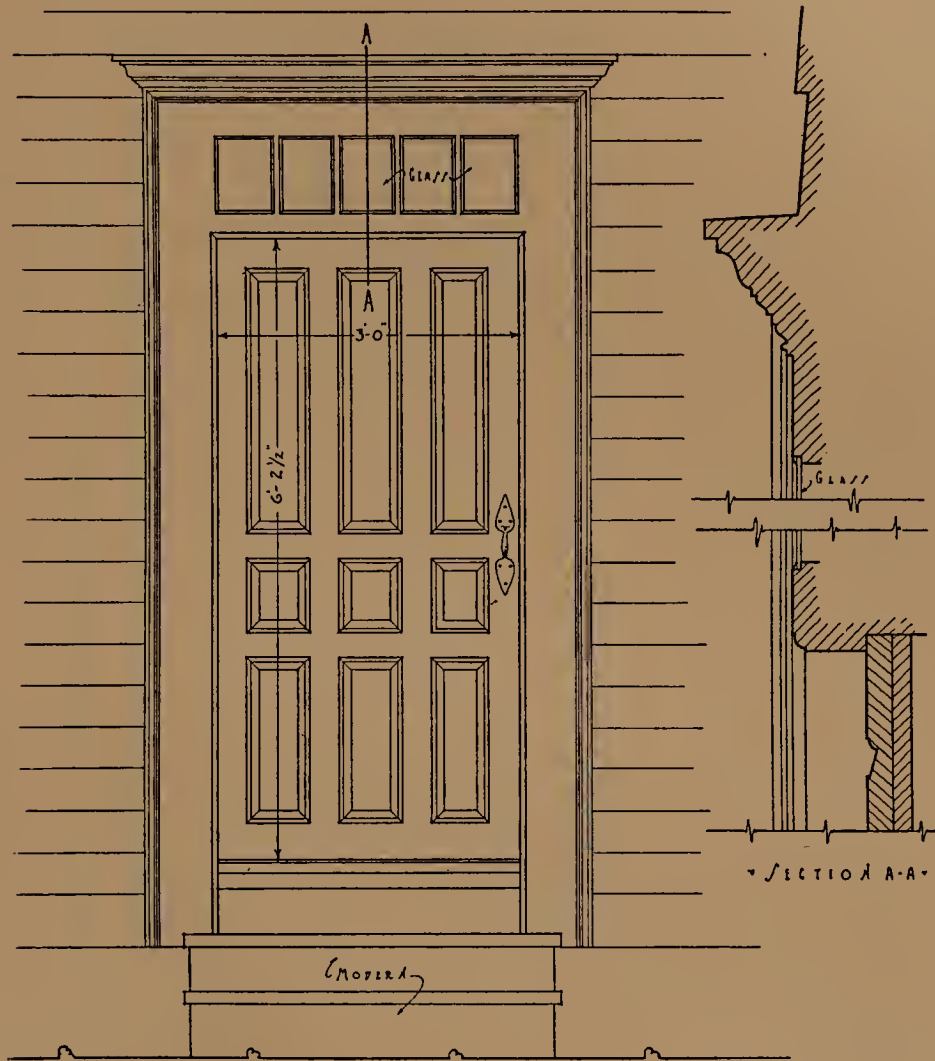
FIGURE 108.

themselves, the rabbet being very shallow; so that but a scant one-eighth of an inch was allowed for putty. Another typical doorway of this period is that of the Philo Bishop house in Guilford (*ante* 1725). (Figure 108.) Simple crown mouldings have been added above the architrave trim; and the whole composition, though of the utmost simplicity, is dignified and well proportioned.

FRONT ENTRANCE  
PHILO BISHOP HOUSE - GUILFORD

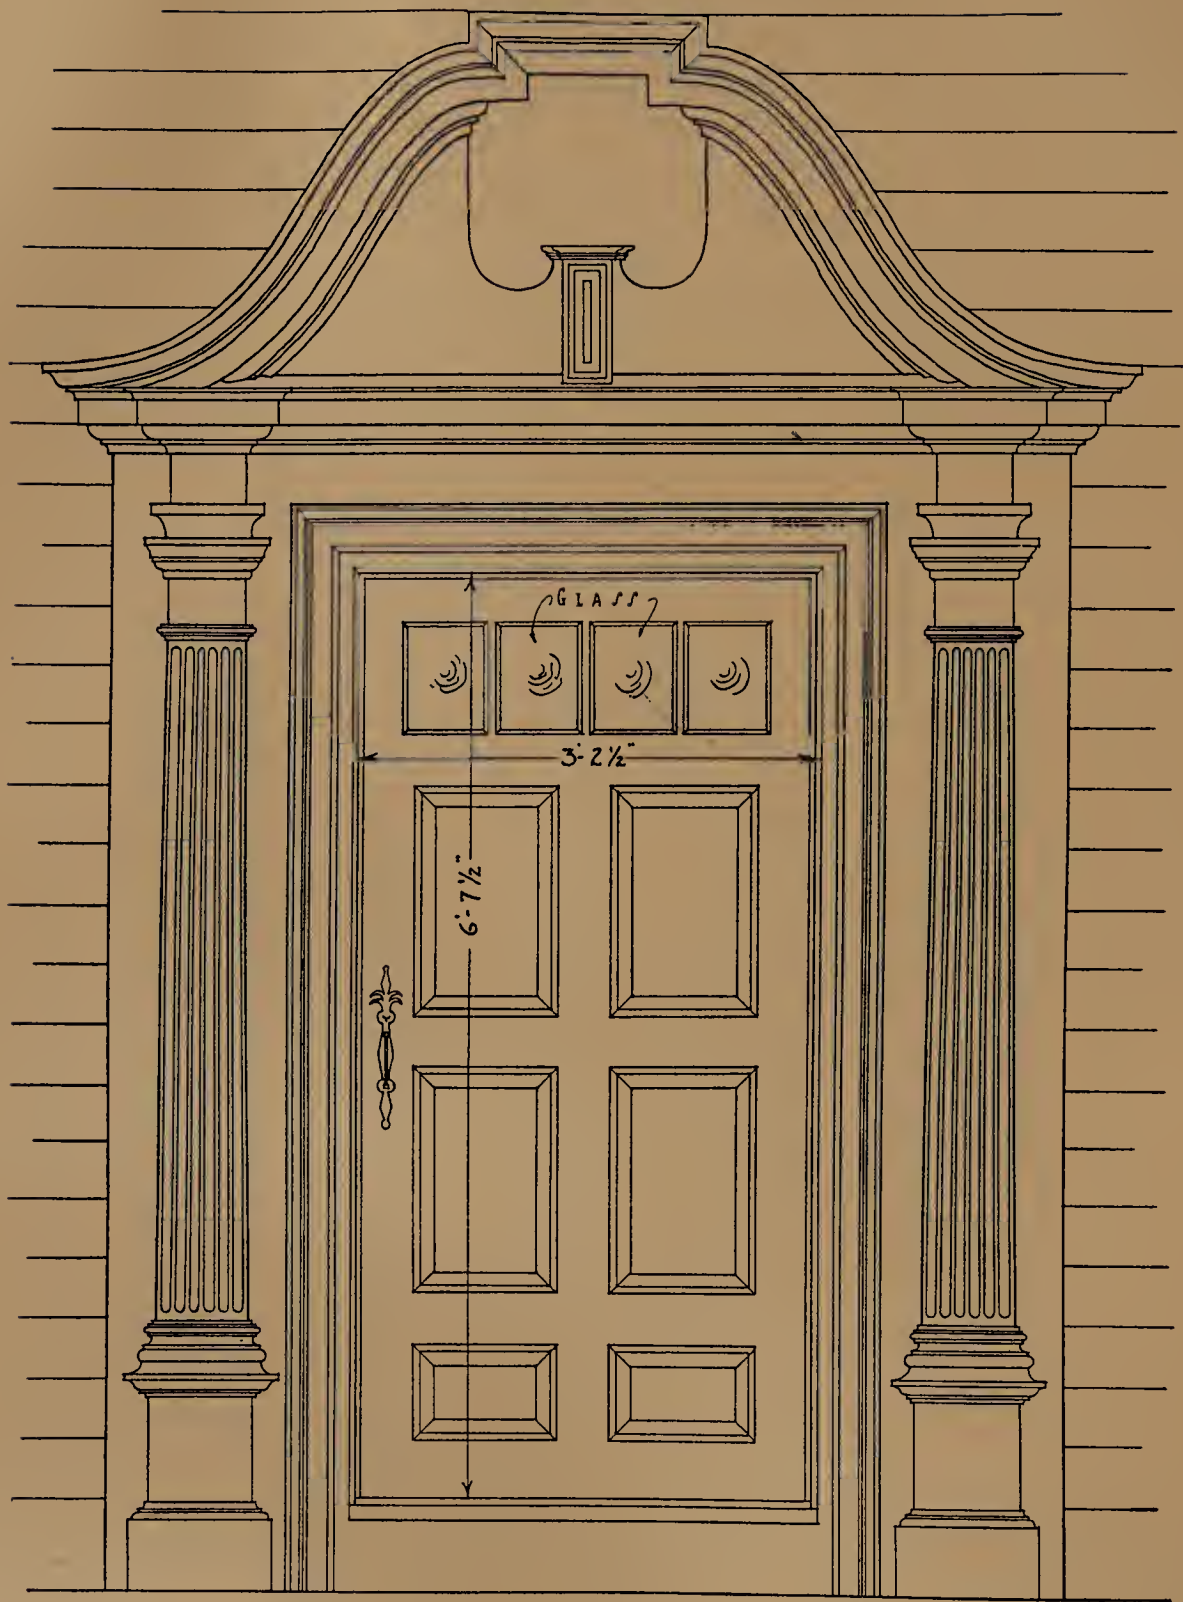
FRONT ENTRANCE  
S W. J. JOHNSON HOUSE - STRATFORD S  
FIGURE 109.

comparatively narrow, gradually became wider, and was eventually replaced by a pair of doors. Single doors were rarely wider than three feet, although the original front door of the Commodore Hull house in Shelton (1771), which is of the "Dutch" type, measures 3 feet 4 inches in width. Double or two-leaf doors were nearly always each two feet in width, so that the total width of the door opening is always close to four feet. The average door height is 6 feet 8 or 10 inches; and it rarely exceeds seven feet.

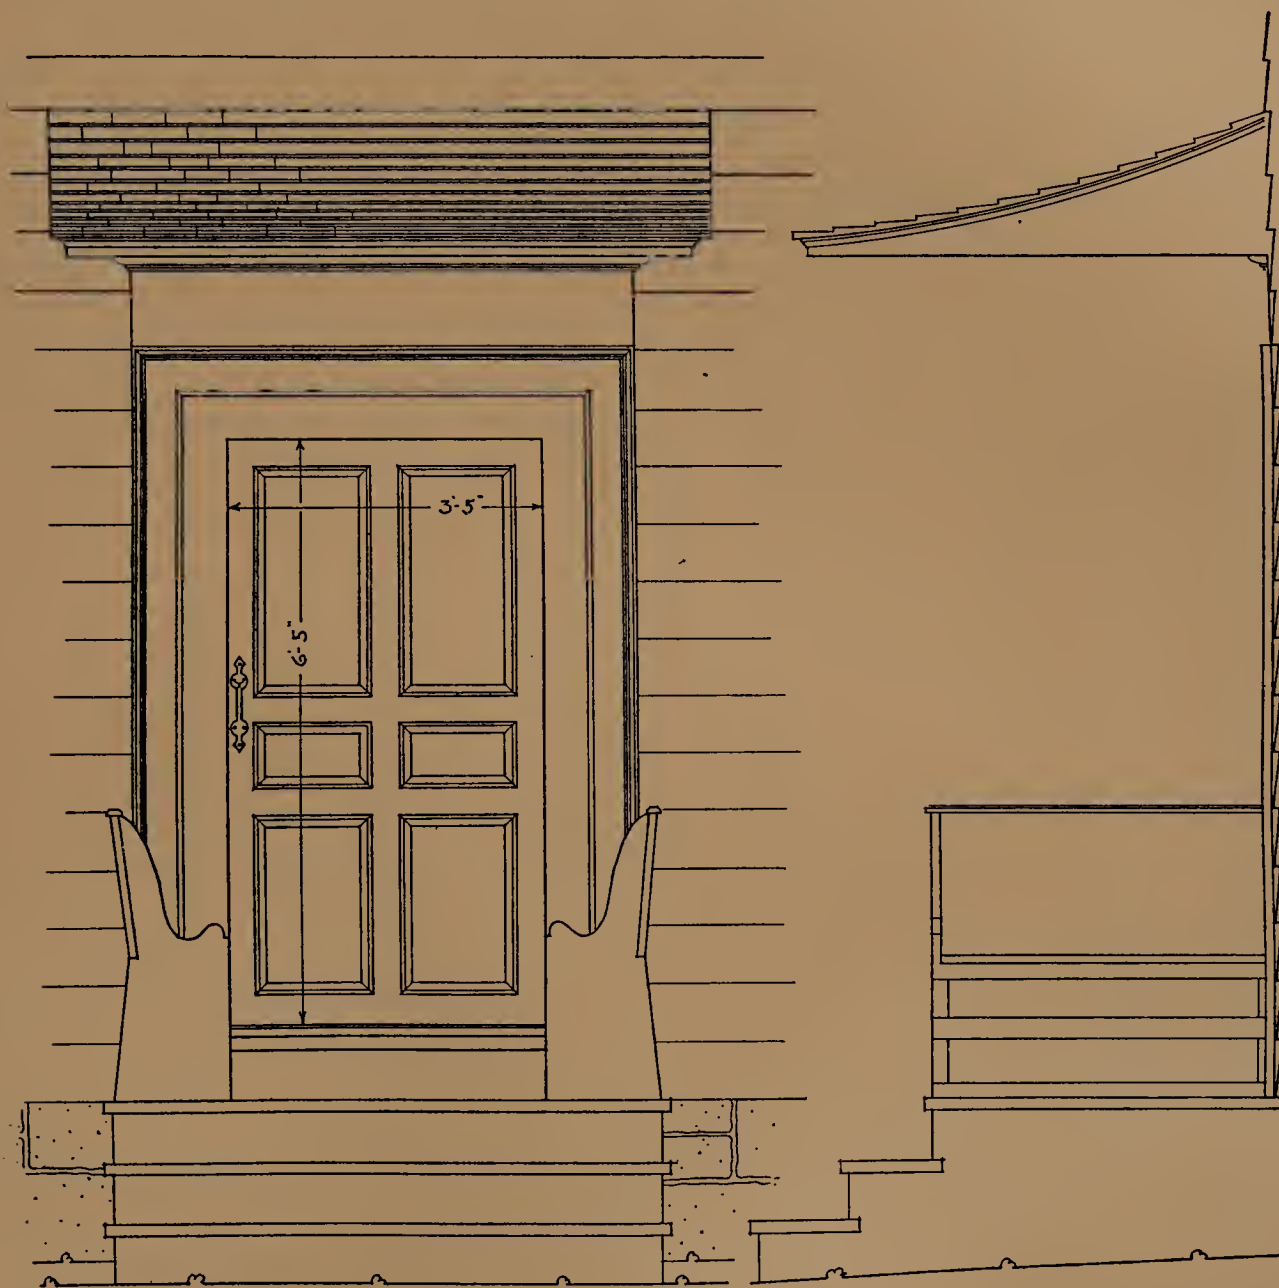
FIGURE 110.

The hooded entrance, such as that of the Tyler house in Branford (*circa* 1710) is of rare form. (Figure 110.) It is strongly suggestive of Dutch influence, traces of which occasionally occur, and which probably found its way into Connecticut *via* Long Island or up the Sound.

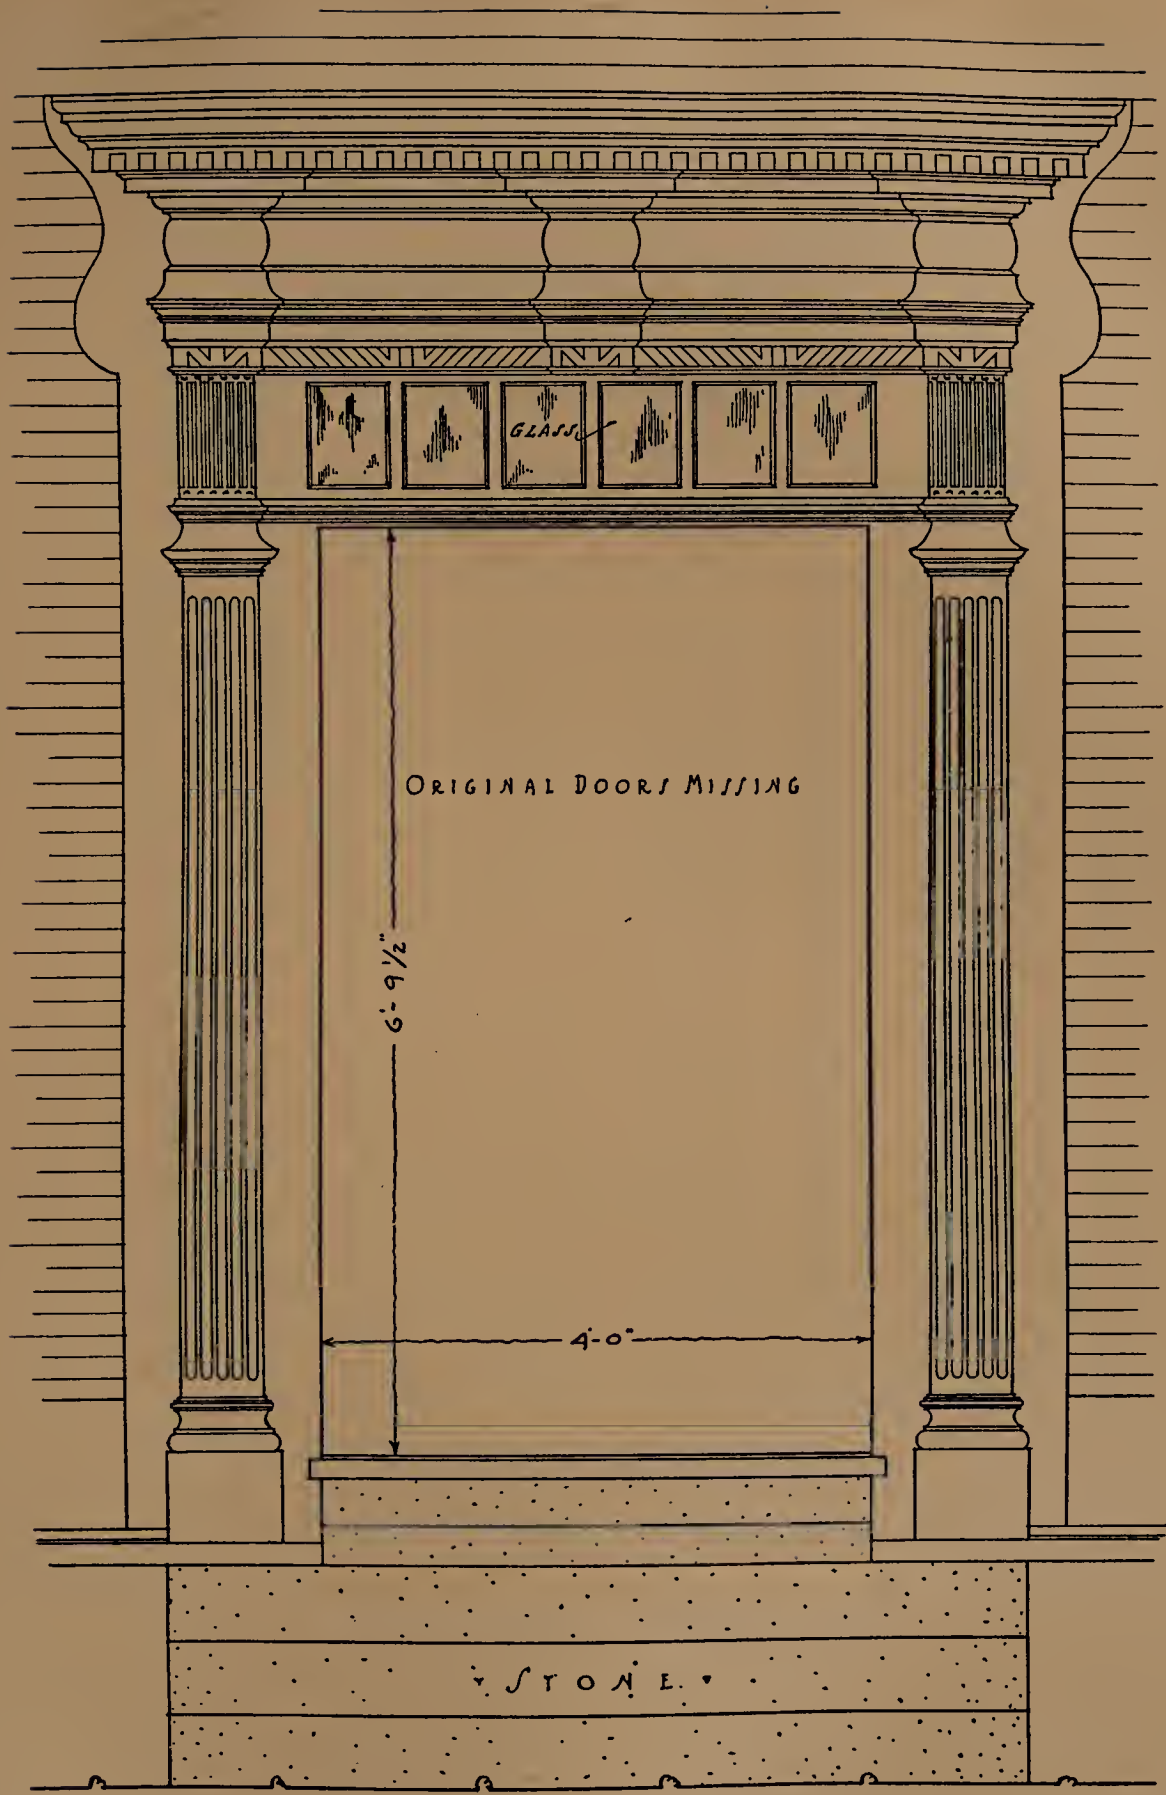
FRONT ENTRANCE  
SAMUEL MATHER HOUSE - LYME  
FIGURE 112.

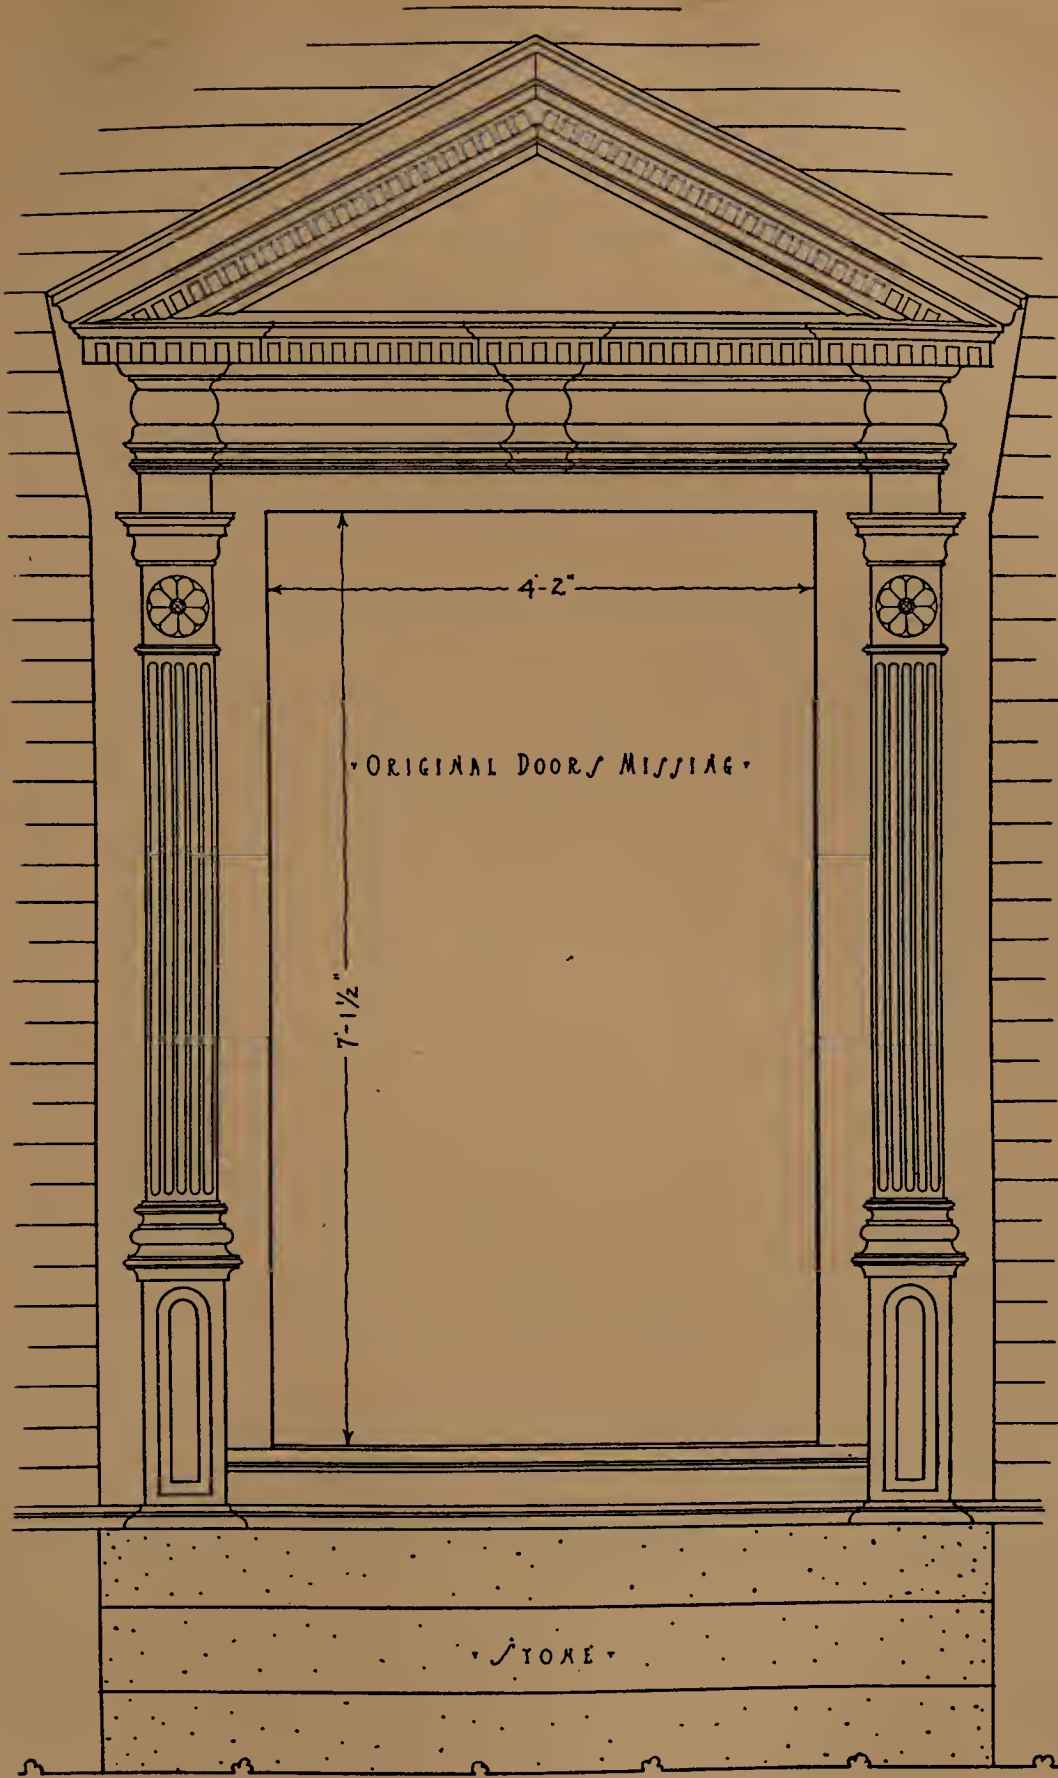
FIGURE 113.

The front entrance of the Trumbull house in North Haven (1761) may be regarded as not only a typical, but actually an excellent example of the pilastered doorway of the pedimented type. (Figure 113.) There again the original doors are missing. The opening measures 4 feet 2 inches in width by 7 feet 1½ inches in height. A pilaster without entasis, of 6¼ inches' width and 7⁄8 inch projection, and having five shallow flutes, is supported by a pedestal on either side of the door. The die of each pedestal is filled with a round-headed panel. The mouldings forming the pedestal cap and the pilaster base are so combined that they form one group. Here, as in the pilaster capitals, there is strong Jacobean feeling; for there is but little suggestion of the Classic in either the individual mouldings or their composition. The pilaster capitals are simple, and their tops line with the door head. The height of the necking, which is greater than the width of the pilaster, contains a six-petalled rosette in shallow carving. This form of decoration is a favorite one for this place; it recurs again and again. Strongly suggestive of the Tudor rose, it is undoubtedly

FRONT ENTRANCE  
TRYMBULL HOUSE - NORTH HAVEN

a recrudescence from that period. From the top of the door opening to the bottom of the architrave is a space of  $4\frac{3}{4}$  inches. The architrave is composed of a group of narrow mouldings which have little relation to each other. A narrow frieze, of but  $3\frac{1}{4}$  inches in height, is of the usual pulvinated form. The cornice is the only part of the entablature which shows any Classical spirit. Its corona exhibits the customary dentil-like treatment in the form of slight sinkages, carved but three-sixteenths of an inch deep. The very steep pitch of the pediment is a characteristic feature, as is also the central break in the entablature, which repeats the breaks on either side of it. As is customary, the board forming the clapboard stop on the outside of each pilaster splays outward to meet the lower angle of the pediment.

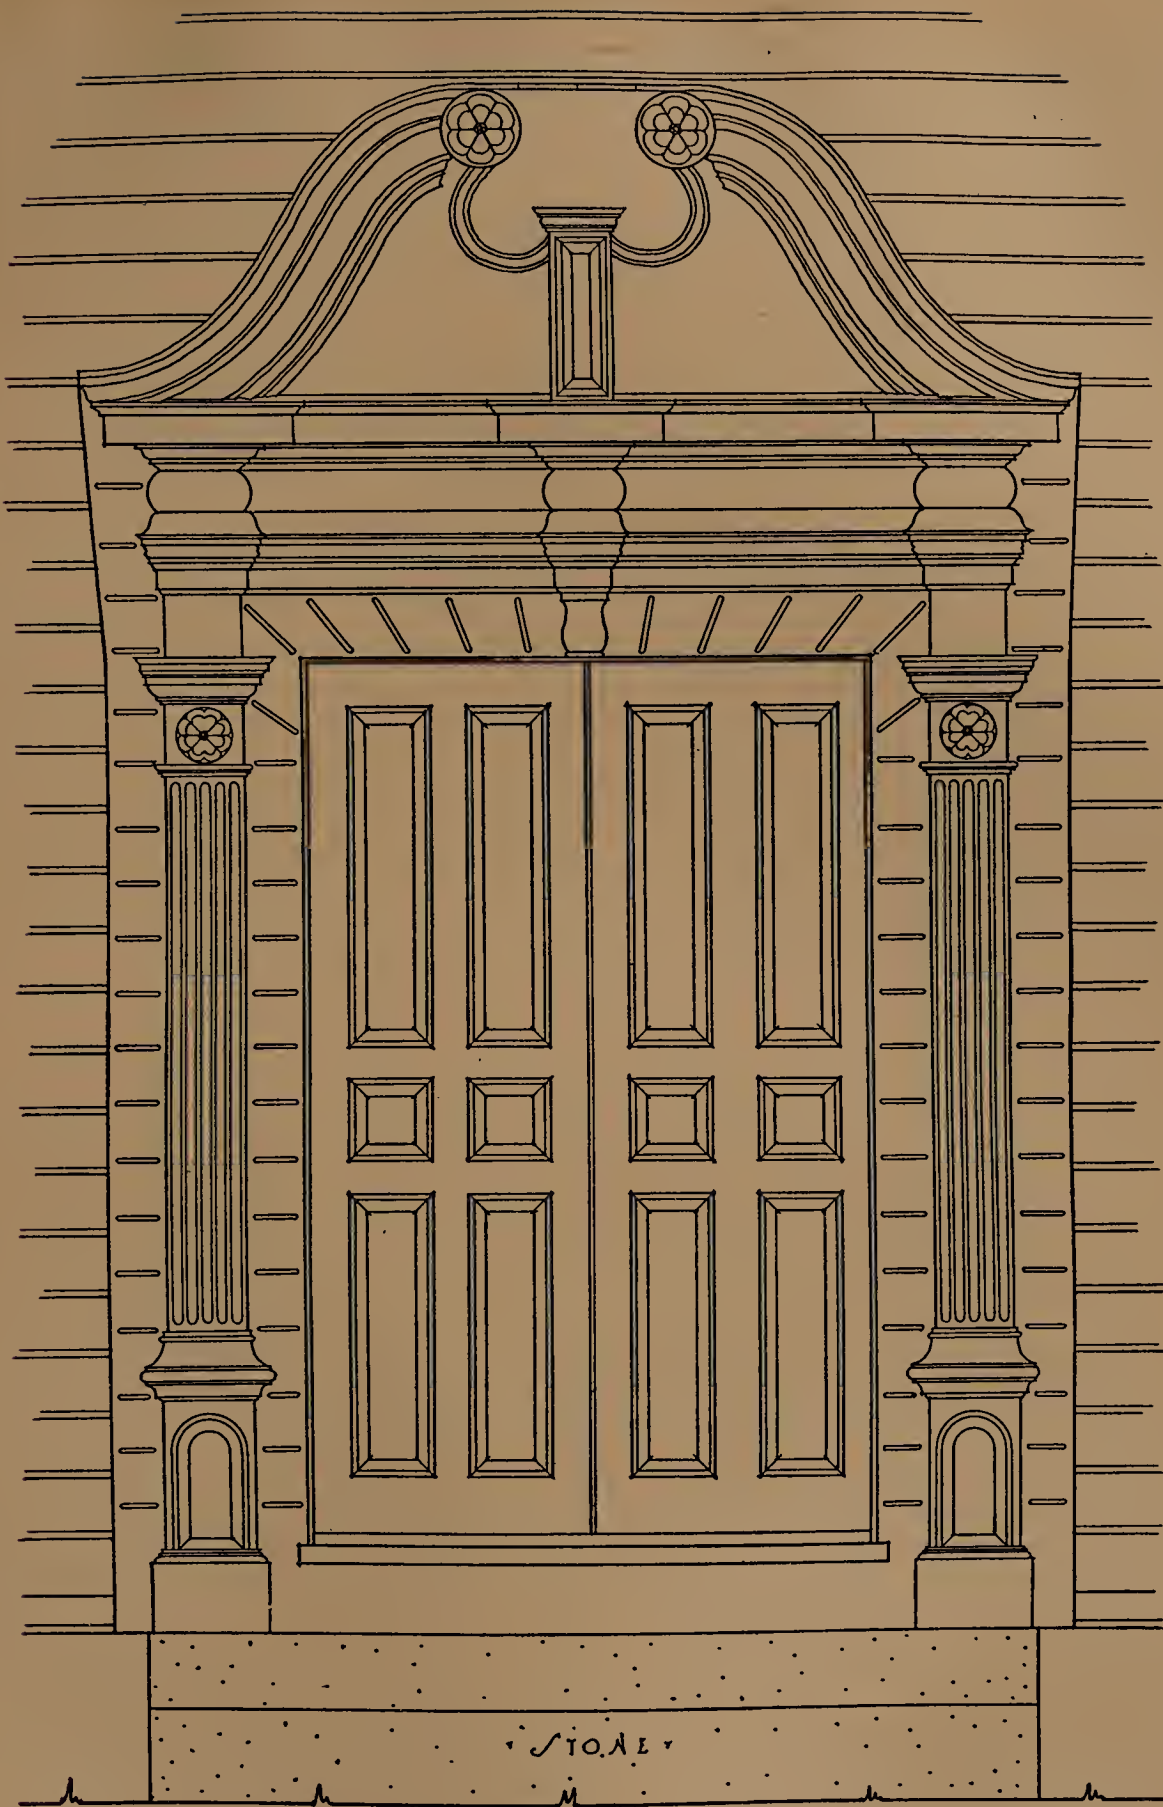
FIGURE 114.

The third type of pilastered doorway, with a broken scroll pediment, is typically represented by the front entrance of the Warham Williams house in Northford (1750), shown in Figure 114. Each door is two feet wide (giving us the usual total width of four feet) by six feet seven inches in height. These doors are of double thickness, and simply panelled. Each leaf is hung on a pair of wrought-iron strap hinges placed on the inside, which reach nearly across the width of the door. Both doors are fastened by means of an oak bar which is dropped into two iron staples, driven into the jambs on the inside. This was a typical mode of door fastening. The pilaster treatment is very similar to that of the Trumbull house doorway. The pilasters project one inch, and each has five shallow flutes. The pedestals which support them have each a round-headed panel, of the usual "bead and bevel" section, in its die—a typical arrangement, as is the single group of mouldings forming the pilaster base and pedestal cap. The pilaster capitals are fairly Classical in their composition, though not in the flavor of their mouldings. The necking, which is high, contains the customary carved rosette, which in this example is of double form. The pilasters exhibit the usual lack of entasis. From the head of the door to the bottom of the architrave is a space of six inches, which is carried around the door opening and cut with shallow three-eighths-inch grooves, crudely suggestive of masonry jointing. The same treatment is repeated on the board forming the clapboard stop, on the outer side of each pilaster. This is a characteristic, in fact almost invariable, feature of this type of doorway. The entablature groups itself into three natural divisions. The architrave is made up of alternated mouldings and plain fillets; as usual, Classical feeling is entirely lacking from its composition. The narrow pulvinated frieze measures but  $3\frac{1}{2}$  inches in height. The cornice is of fairly regular composition, its principal member being a broad corona which does not bear the customary denticulated carving, such as is displayed by the doorway of the Old Inn at East Windsor (*circa* 1753). (Plate XXIII.) The crown moulding of the cornice rises in a steep curve of reverse form, and terminates on each side in a carved rosette of the usual six-petalled shape. Its course is repeated by the members which occur beneath it. Its abrupt rise and its general steepness of contour give the whole composition a great deal of style and distinction, utterly lacking in certain late examples, which display a flatter curve of more "lazy" outline. The central break extending up through the entablature supports a narrow panelled pedestal, the top of which is connected by loop-shaped

• FRONT ENTRANCE •

✓ WARHAM WILLIAMS HOUSE - NORTHFORD ✓

mouldings with the rosettes on each side. This pedestal, in doorways of this type, often supports some form of carved or turned ornament. The whole scroll arrangement of this entrance is flashed with heavy sheet lead, a survival of English usage.

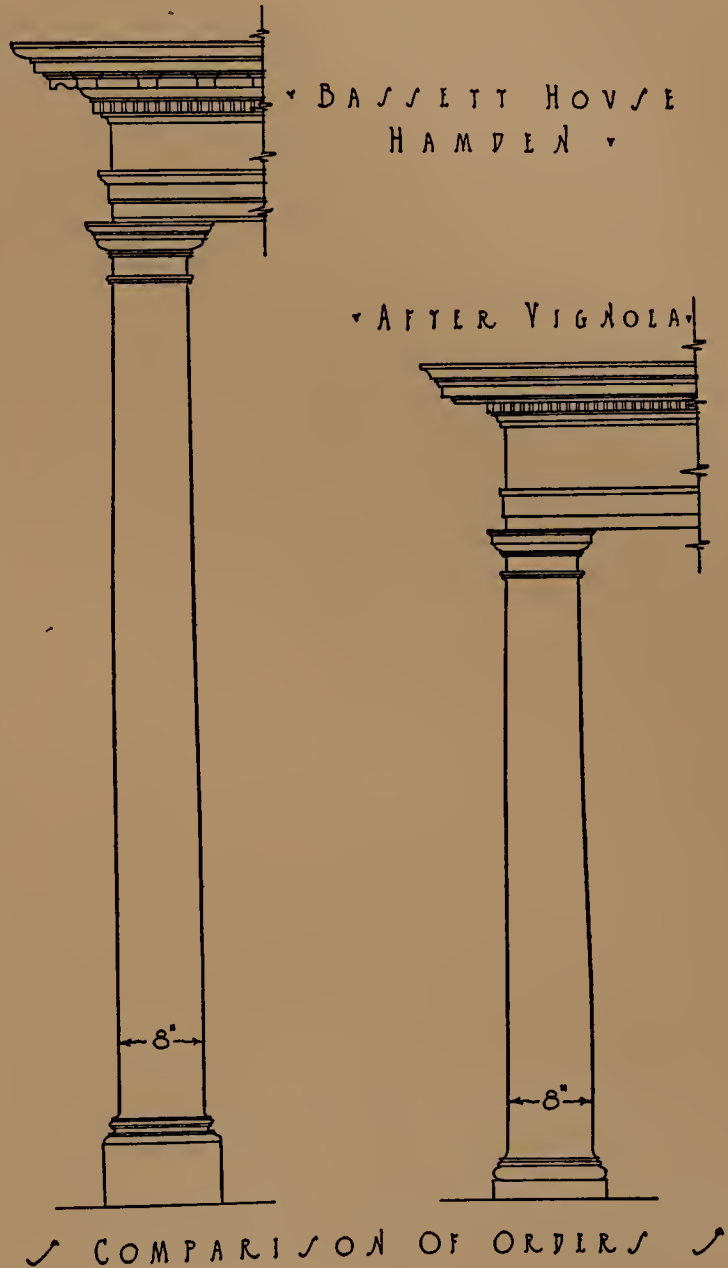
FIGURE 116.

This entrance is an admirable illustration of a subject discussed in the chapter on Mouldings: namely, the translation which was so skillfully effected in converting the proportion of a stone idiom to one of wood. Figure 116 shows the order employed in the Bassett house entrance, drawn first according to the canons of Vignola (A) and then as it is actually executed (B). In A the diameter of the column, eight inches, is taken as the unit of measurement. It will be seen that the wooden column of new proportion is about  $10\frac{1}{2}$

diameters high, whereas the stone column, in accordance with Vignola's standards, is but eight diameters. This comparison is of value in that it clearly shows how an understanding of the new material, thus finally arrived at, made possible an architecture of greater lightness, grace, and elegance.
